# The Dan River Coal Ash Release: Description & Timeline of Events

Environmental Review Commission  
February 17, 2014

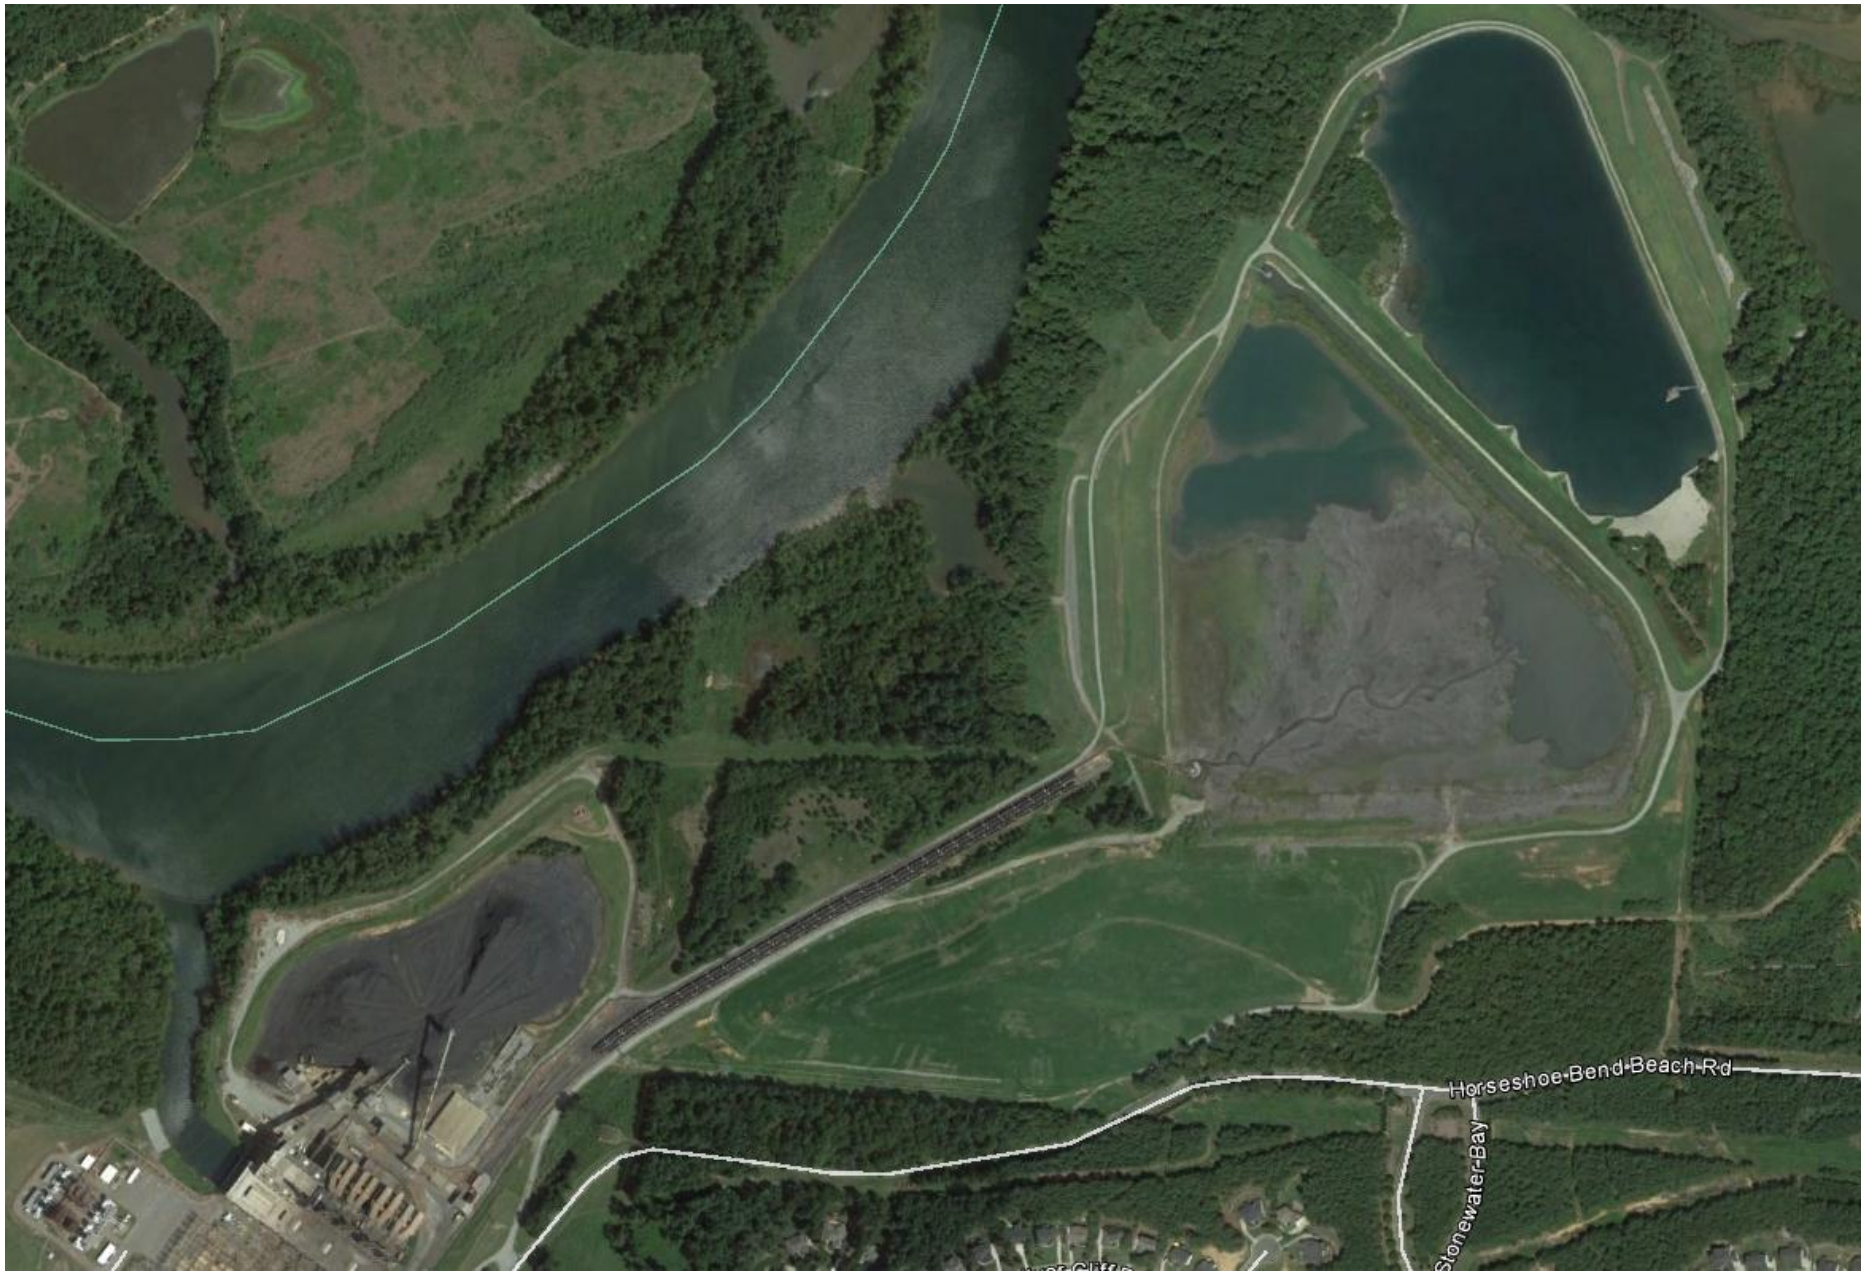
Raw coal is brought in by rail and stored on site.

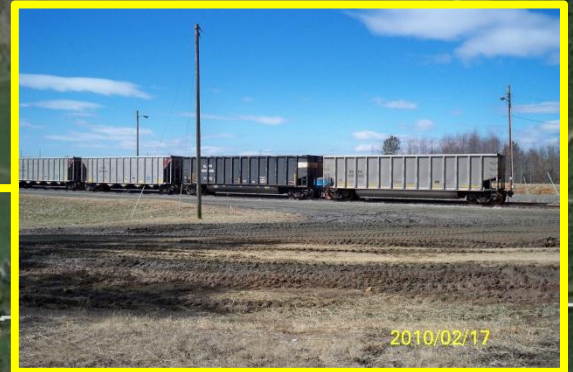
Raw coal is conveyed into the power plant and burned to boil water that drives turbines, creating electricity.

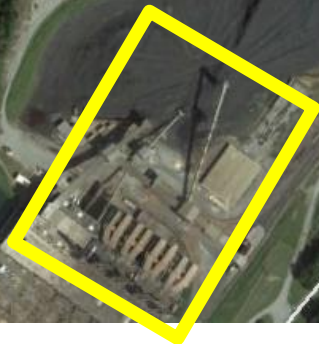
After being burned, the ash from the coal is sluiced with water from the plant into ponds where the solids settle out.

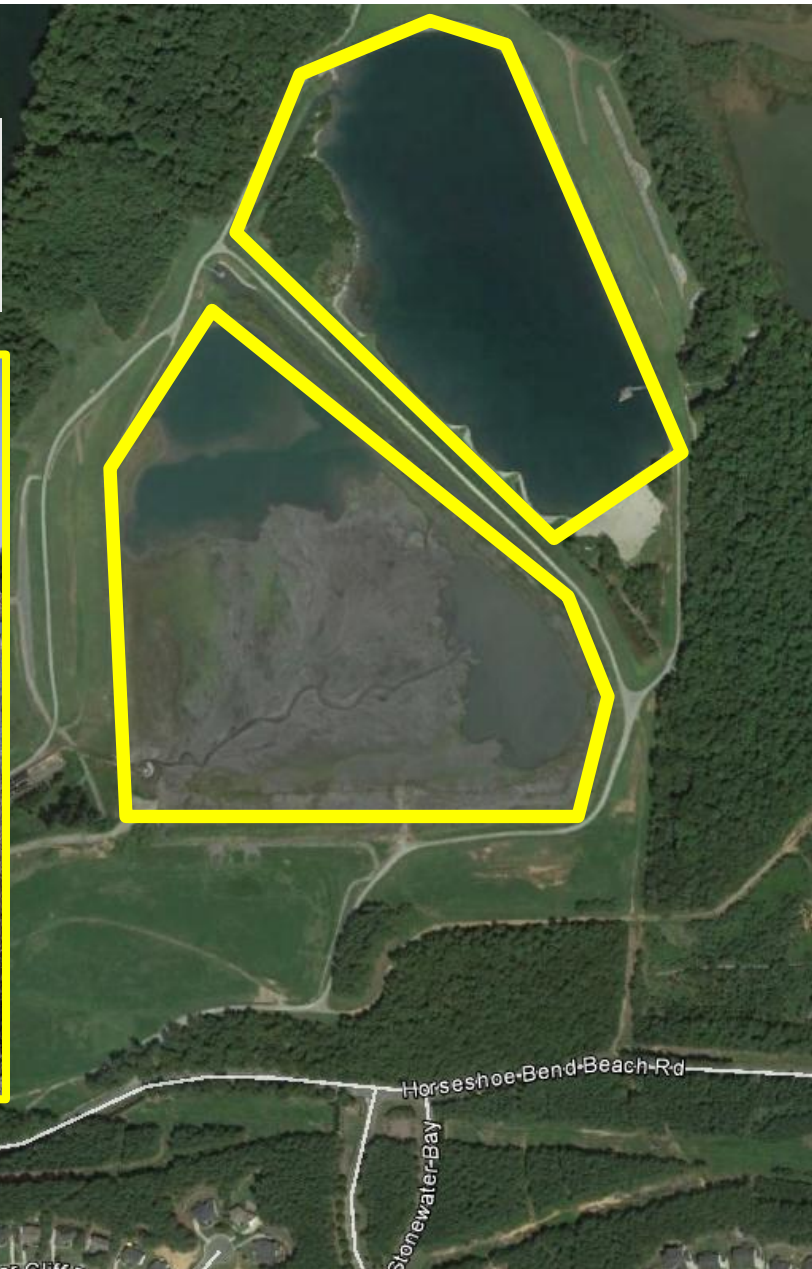
After the solids settle out in the ponds, the water in the pond is then discharged to surface water.

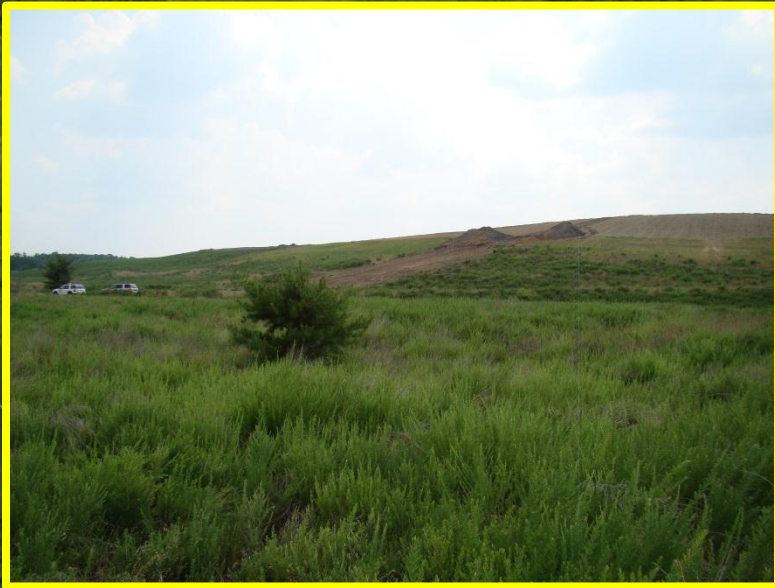
Some coal ash that settles out in the ponds gets dredged out and stored in piles or on-site landfills. This ash can also be applied in other applications for beneficial reuse such as structural fill and in building materials.

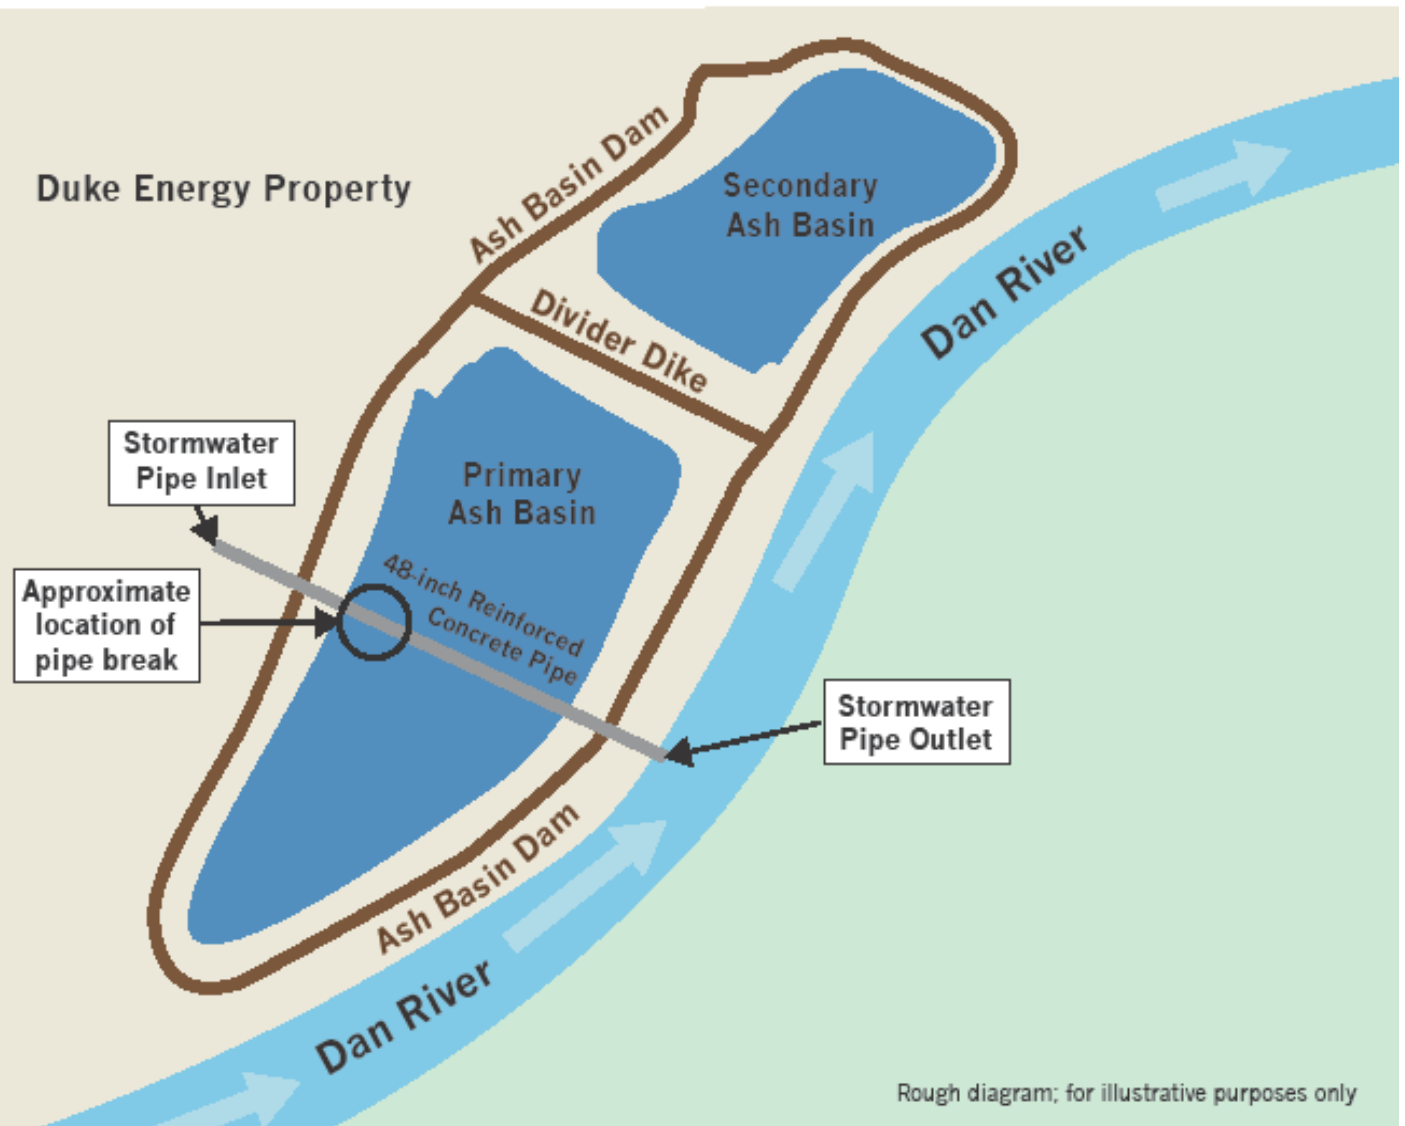
# Dan River Steam Station

- Coal ash ponds at Dan River Station retired in 2012.
- On the afternoon of Feb 2 (Sunday) a stormwater pipe under the primary 27 acre coal ash pond fails.
- Corrugated metal portion of pipe fails.
- Failure of pipe under the pond allows the release of coal ash & water to the adjacent Dan River.
- Partial collapse of interior pond berm.
- Duke notifies Eden/Danville/Rockingham County.
- Duke calls Division of Emergency Management hotline Sunday evening.

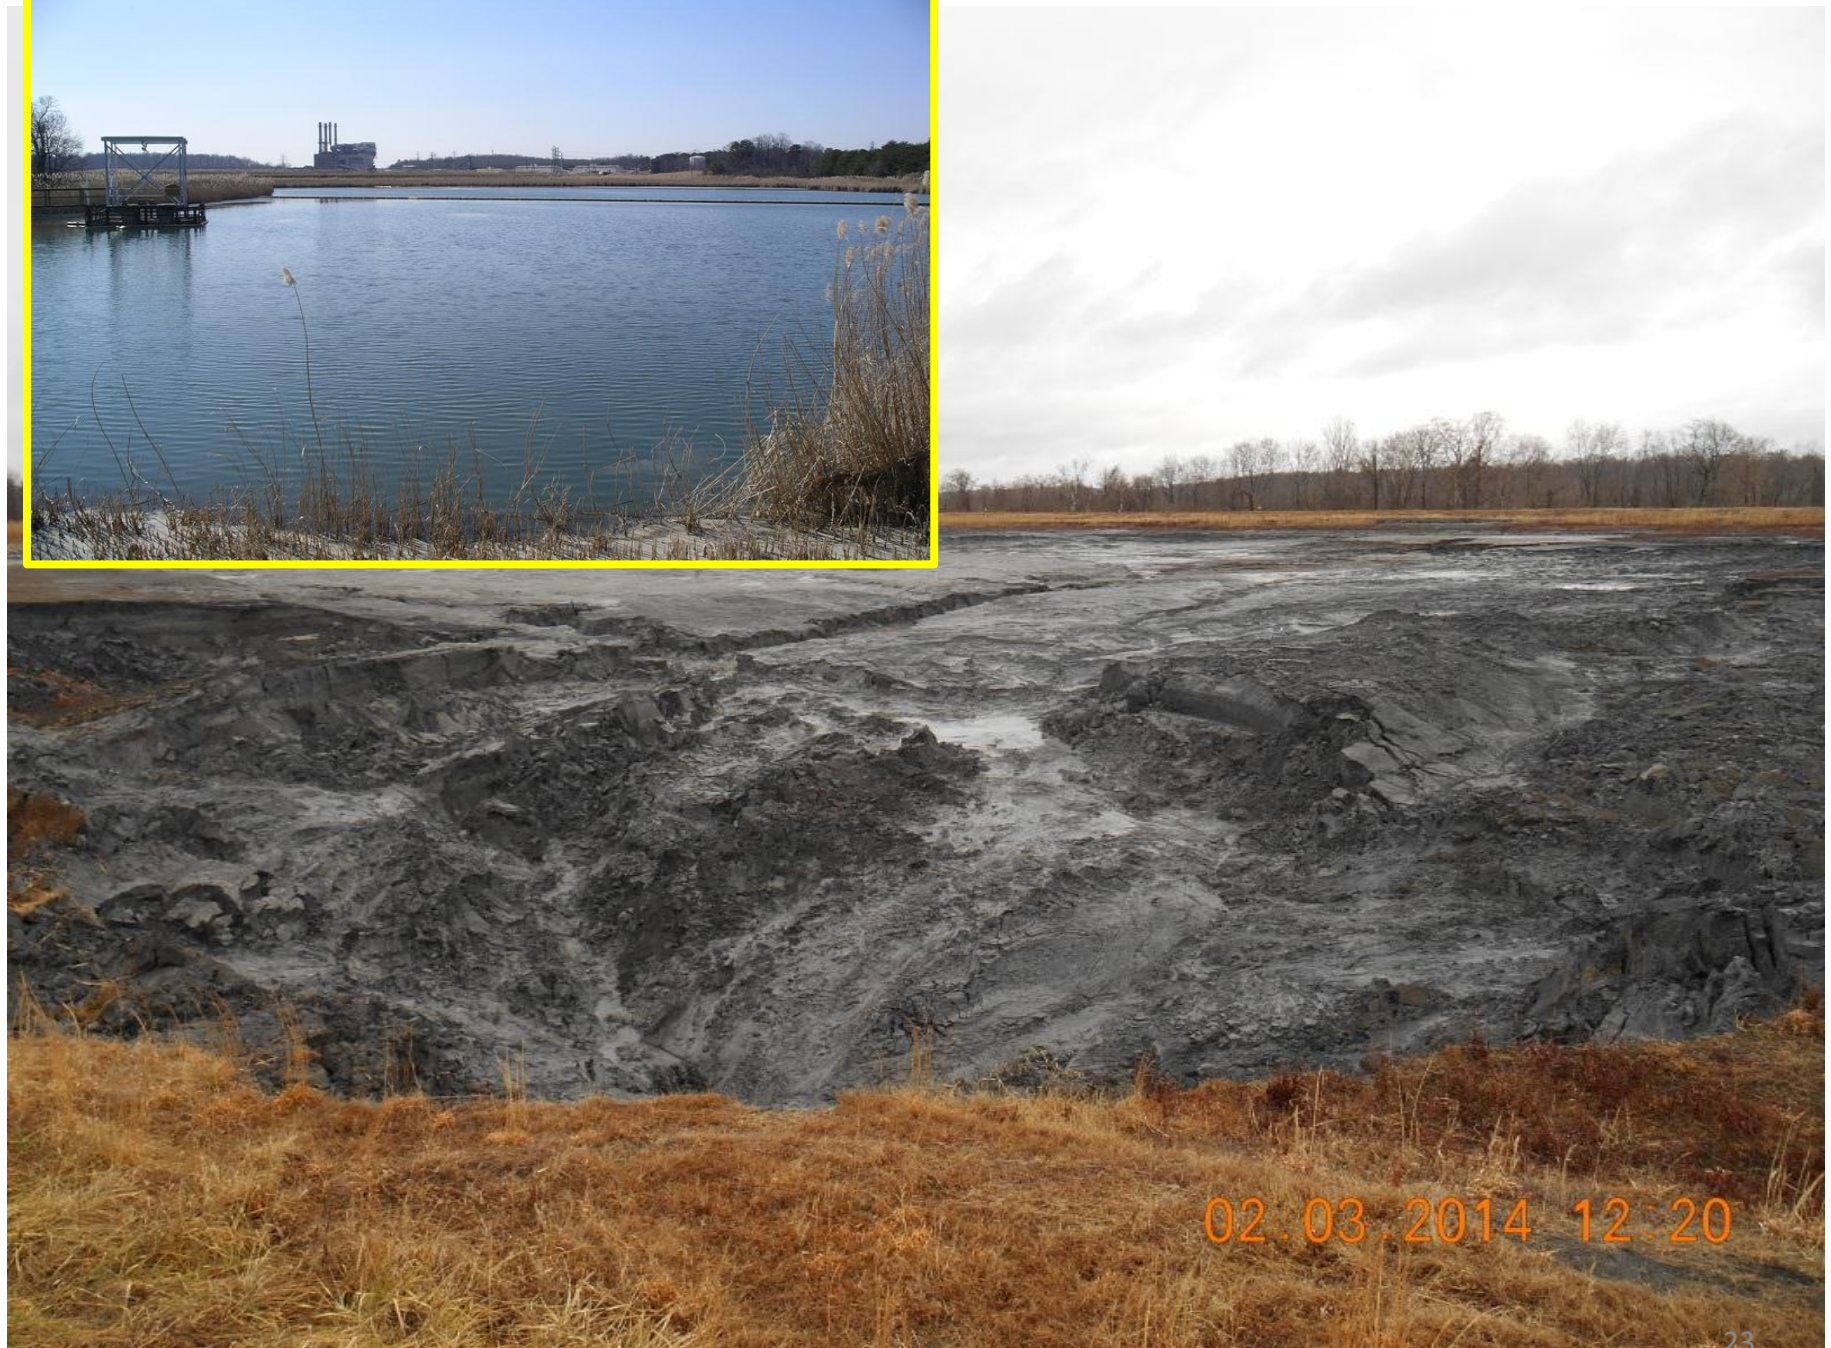
02.03.2014 12:20

- DENR Regional Office personnel notified.
- DENR staff travel immediately to power plant.
  - Both water quality & dam safety personnel.
- Release of coal ash continues through failed pipe.
- Duke mobilizes to try to stop release.
  - Attempts to stop flow w/air bladders in pipe.
- DWR ensures all downstream water supplies notified.
- Duke & DENR issue separate press releases in afternoon.
- DWR begins collecting water quality samples.
- DENR notifies EPA / EPA reps on site before midnight.

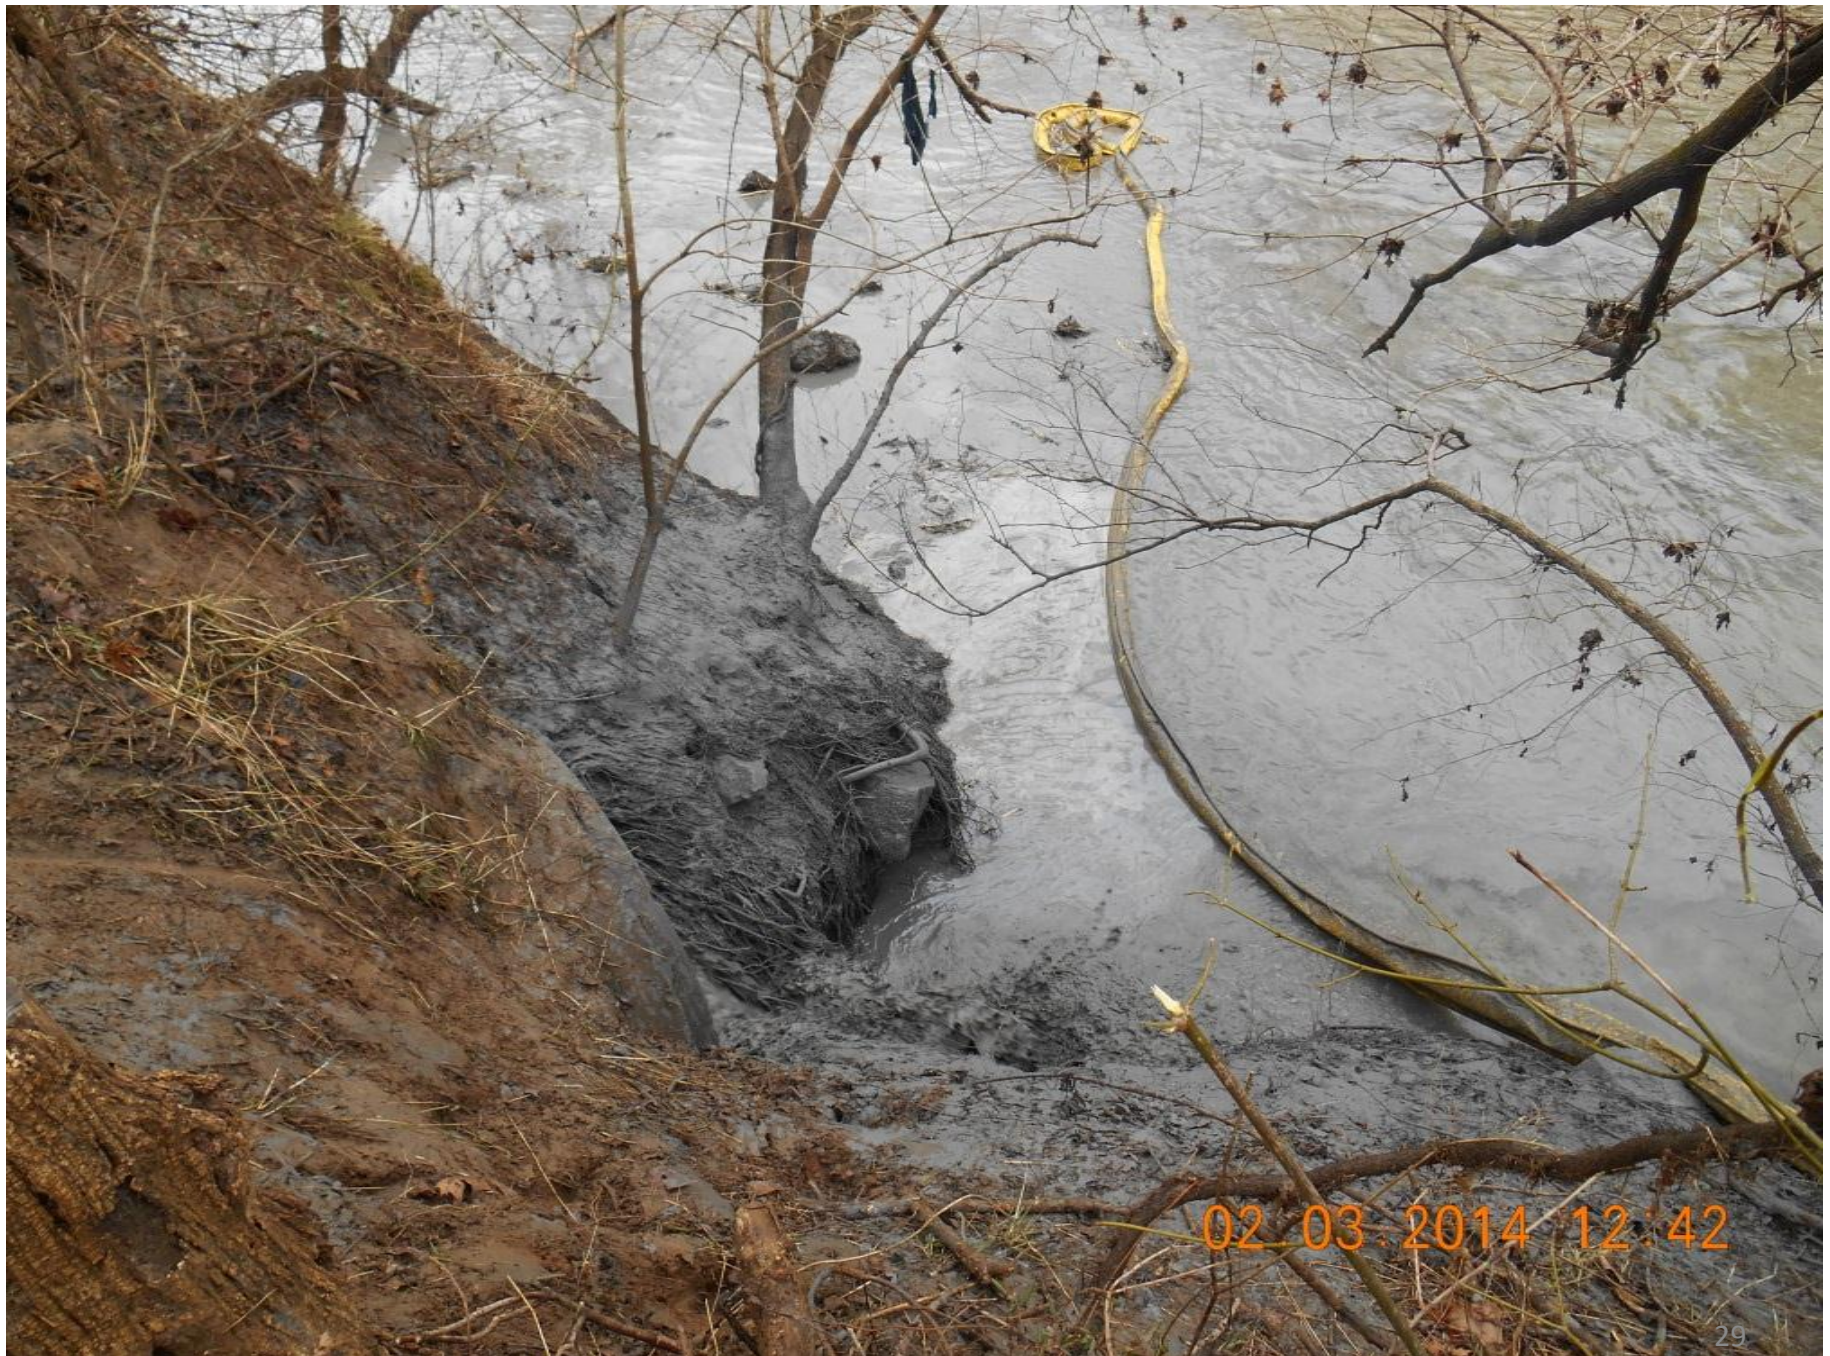
02\_03\_2014\_12:42

- Secretary Skvarla visits site, receives detailed briefing.
- Secretary Skvarla discusses situation w/EPA Region 4 Administrator & Director of VA Dept of Env Quality.
- US Fish & Wildlife Service on site.
- Initial samples are delivered to DWR chem lab for analysis.
- Danville able to treat water, provide safe drinking water.
- Duke continues repair work:
  - Duke commences re-routing all discharges away from ash pond.
  - Pipe failure located and excavation begins.
  - Video camera inserted 120 feet into pipe from pond failure.
- Release reduced, but not eliminated.
- Sampling & monitoring efforts continue through duration.
  - Coordinated between DENR/EPA/USFWS.

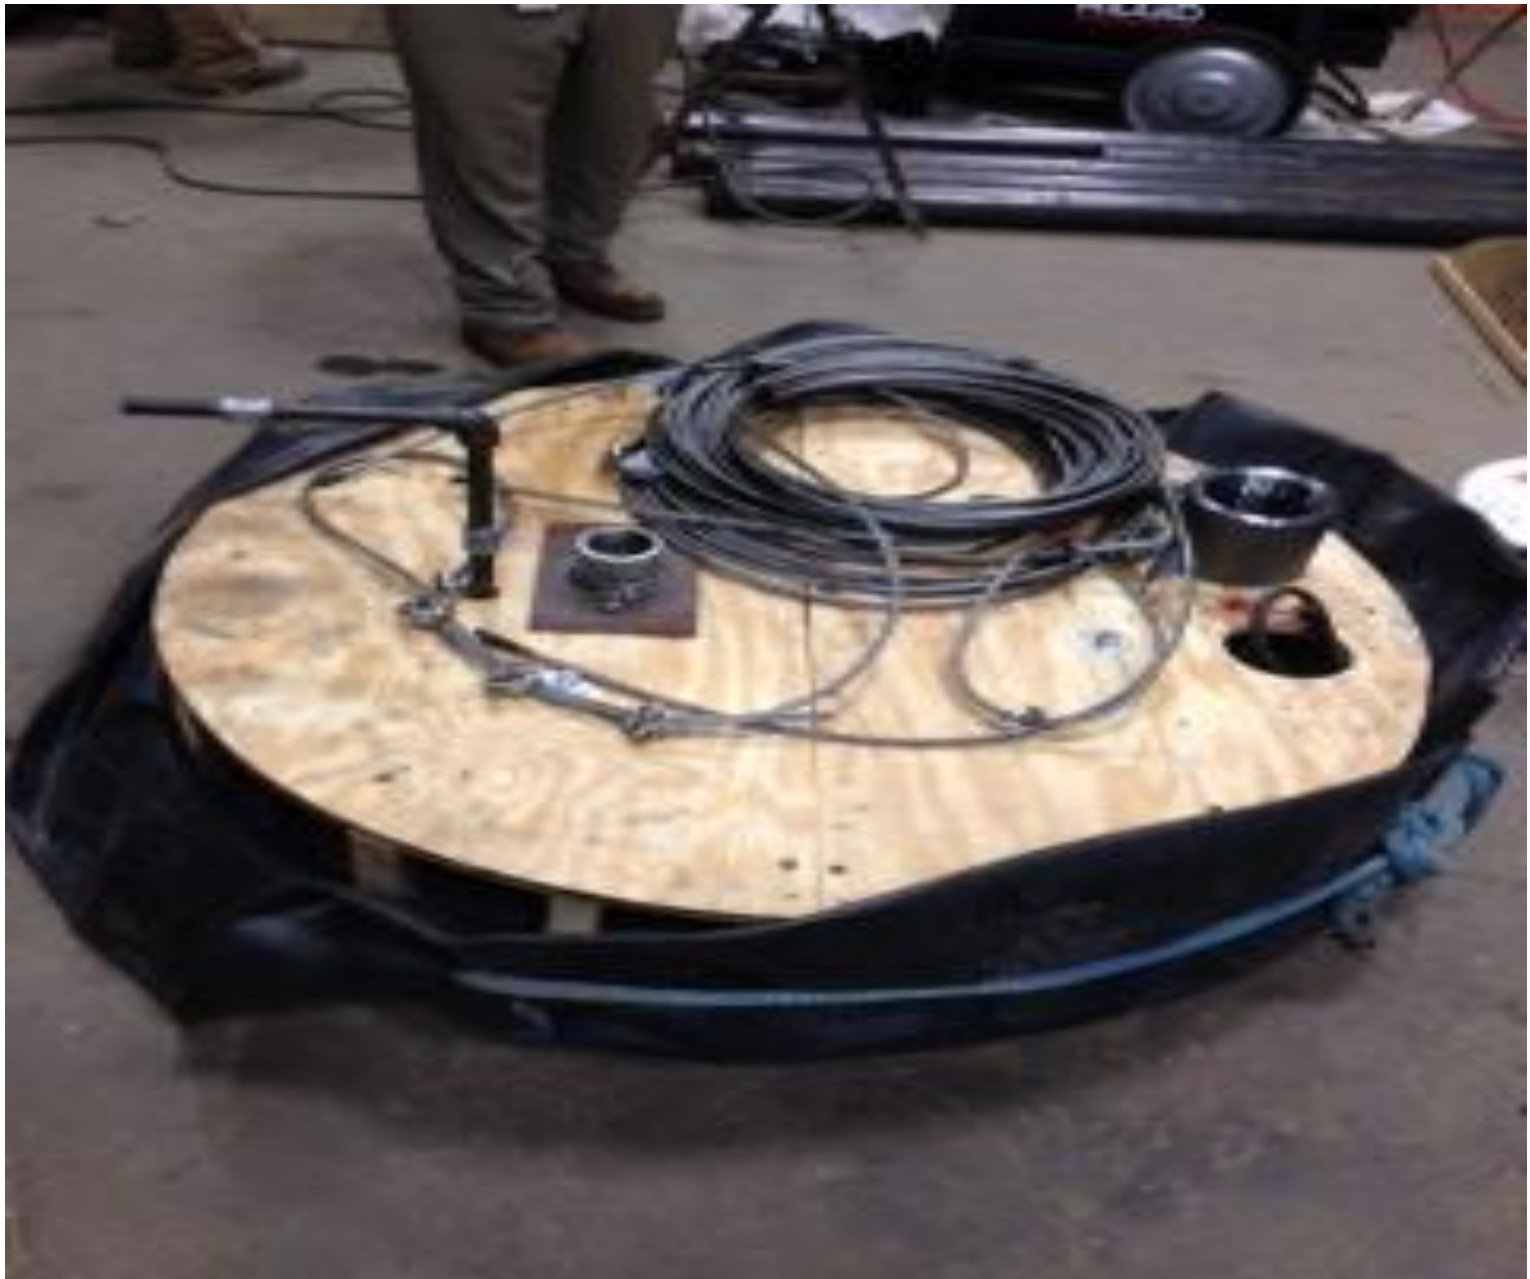
- DWR begins assessment of sediment deposition & development of long term monitoring plan.
- No discharge due to sandbag dam / pump.
- Bulkhead constructed for grout sealing operation.
- Wooden bulkhead to be inserted into pipe from river opening of pipe.
- Grout will be pumped into pipe to bulkhead and then pipe will be sealed with concrete cap.
- Virginia DEQ on site.
- Completed sampling results for Mon/Tues published.

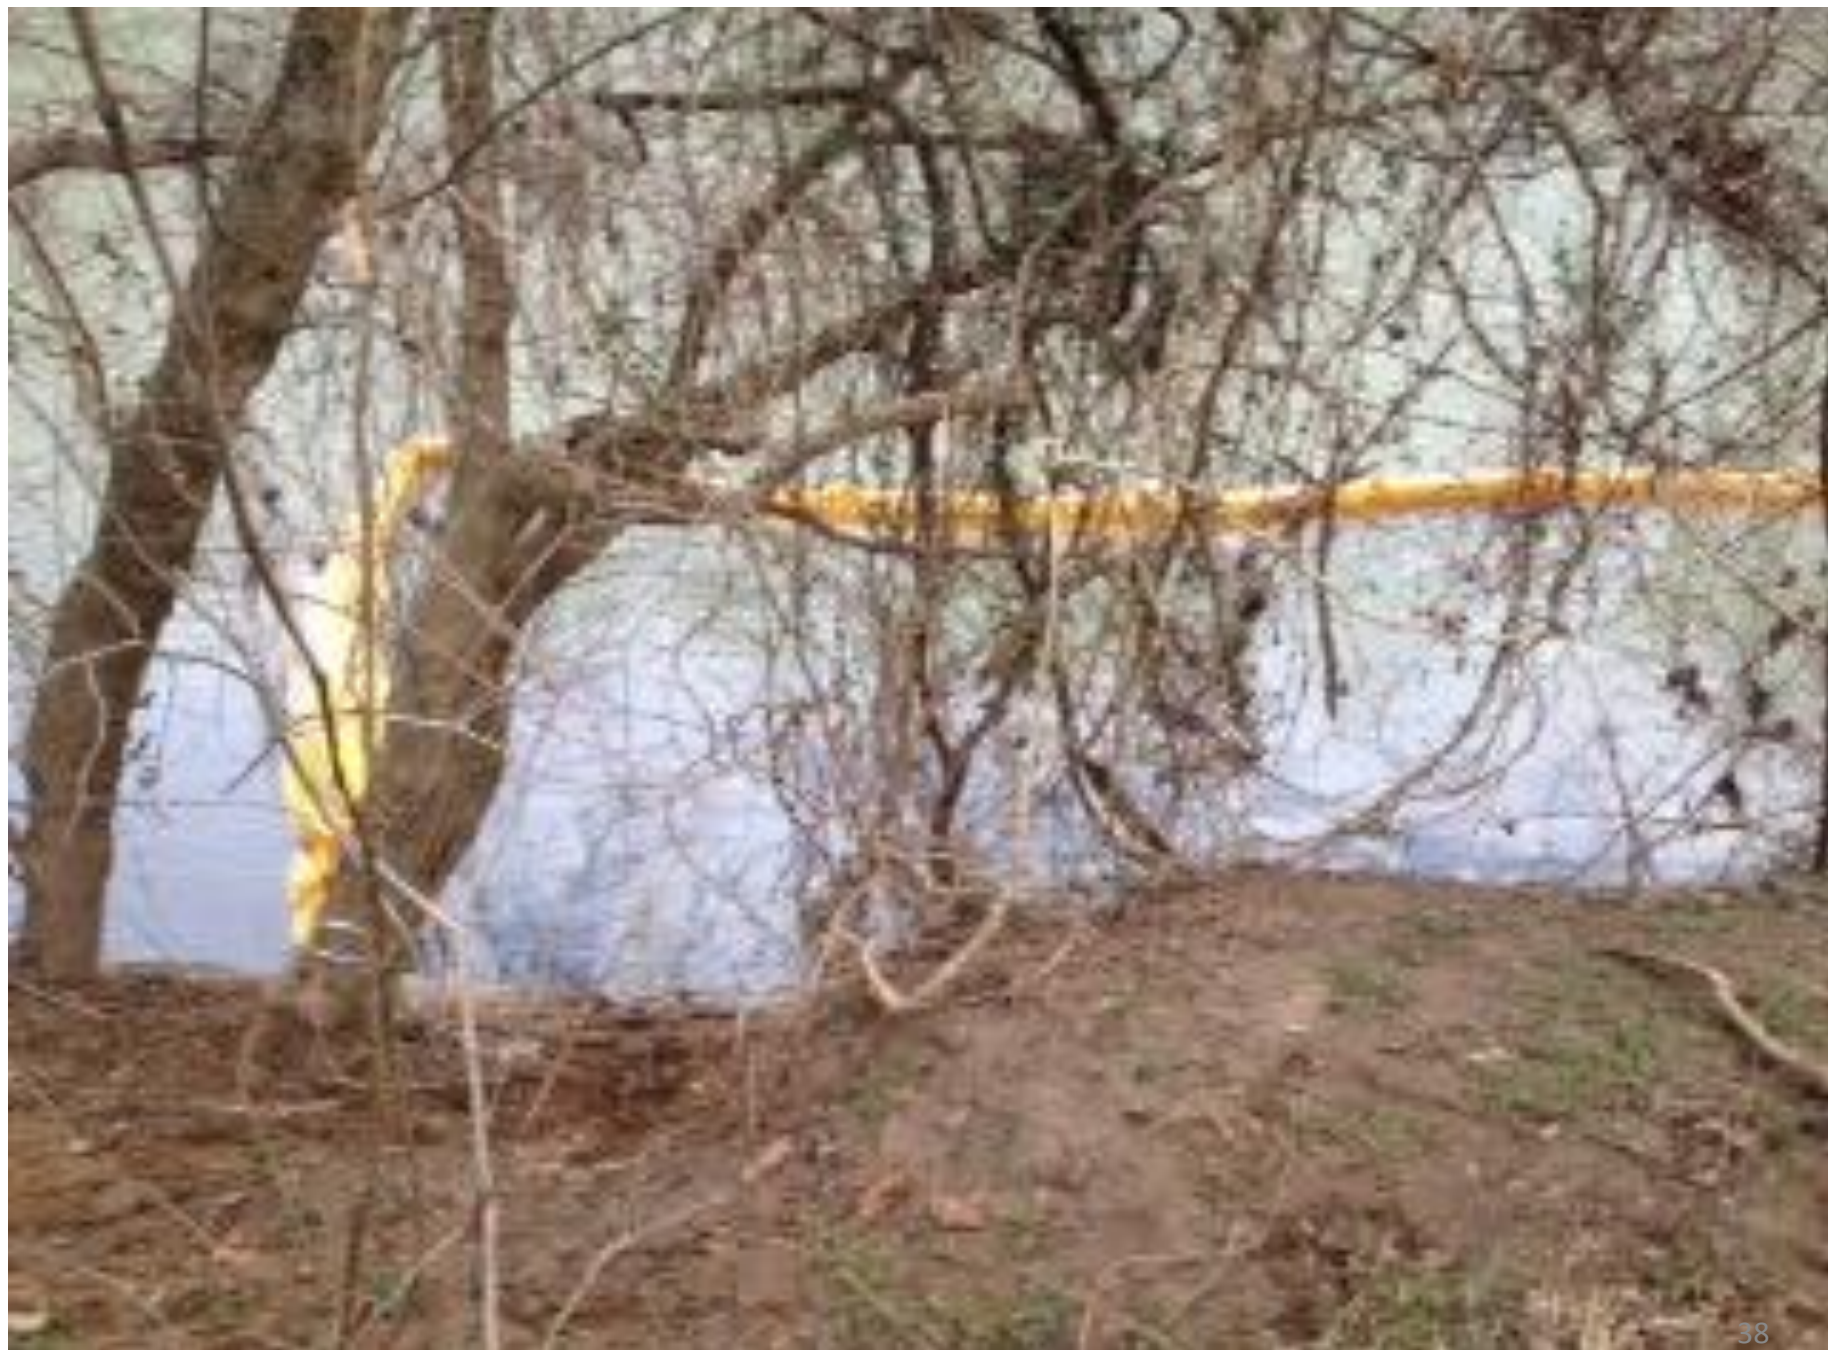
- Excavation of pipe near original failure continued.
  - To allow grouting/concreting of remaining pipe.
- Plans developed to remove a mound of approx 300 cubic yards of ash discovered by discharge point.
  - Coordination with Army Corps/DENR/USFWS/EPA.
